The Lost Kame is no longer lost!

Glacial Park Wetland Restoration Project—August 2011

By Ed Collins, Natural Resource Manager

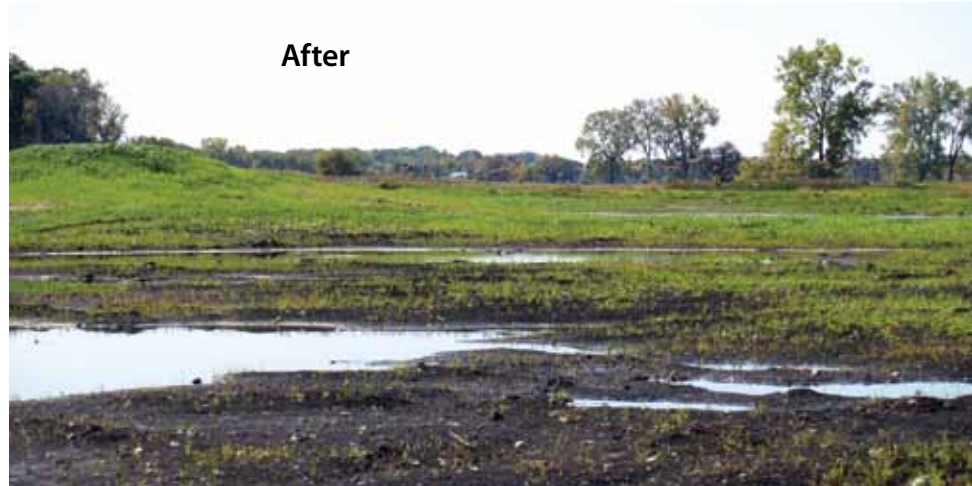
Facing north, new kame in the foreground, existing kame in background.

The kame material was moved back to where it was removed from five decades ago. The kame was then pushed completely across the former pond re-creating the two sub watersheds that once existed prior to the 1950's.

- ▲ Poised 12' high, a bit smaller than the original, the Lost Kame is no longer lost! The dark black organic soils are clearly visible from the deck of the visitor center and it is hard to believe they were once buried under nearly three feet of fill material.
- ▲ The south end of the "pond" has been rough graded so the slopes are much gentler and flow into the water gracefully rather than dropping abruptly from eight feet above. Two things find these slopes within hours of their creation. The first is ground water, which moves molecule by molecule through
